# PVC Pipe has Lowest Break Rate according to Utah State University Buried Structures Laboratory Researcher

# ***Water Main Break Rates In the USA and Canada: A Comprehensive Study April 2012***

Utah State University  
Buried Structures Laboratory

Steven Folkman, Ph.D., P.E.

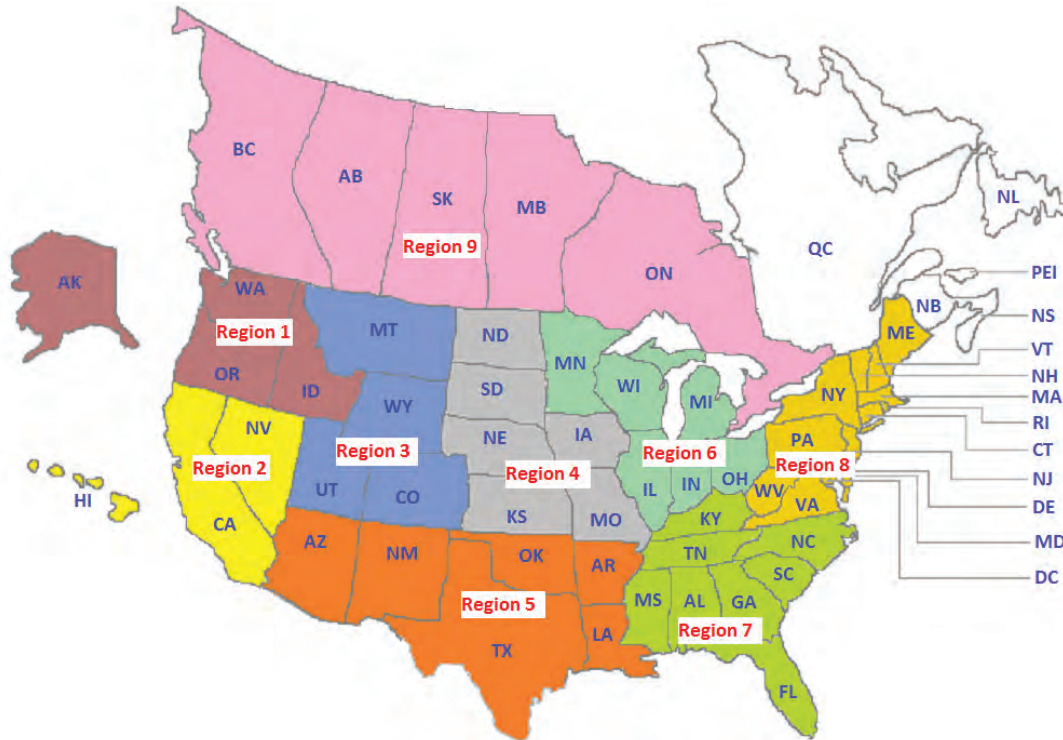
Figure 1. Regions used to report survey results.

The regions defined in the study are used here to indicate the wide geographical distribution of the respondents. Table 1 lists the number of respondents in the basic and detailed surveys from each region, and Figure 1 illustrates the locations of the nine different regions used in this report. The provinces in Canada with a white color did not have respondents to the survey. Figure 2 illustrates the miles of water main pipe that were reported in the basic survey on a regional basis. Similarly, Figure 3 illustrates the miles of water main pipe on a regional basis from the detailed survey. A total of 32,130 miles of pipe was reported by respondents in the detailed survey. It is noted that the respondents were distributed across a large survey area, but this study is still more comprehensive than other studies to date.

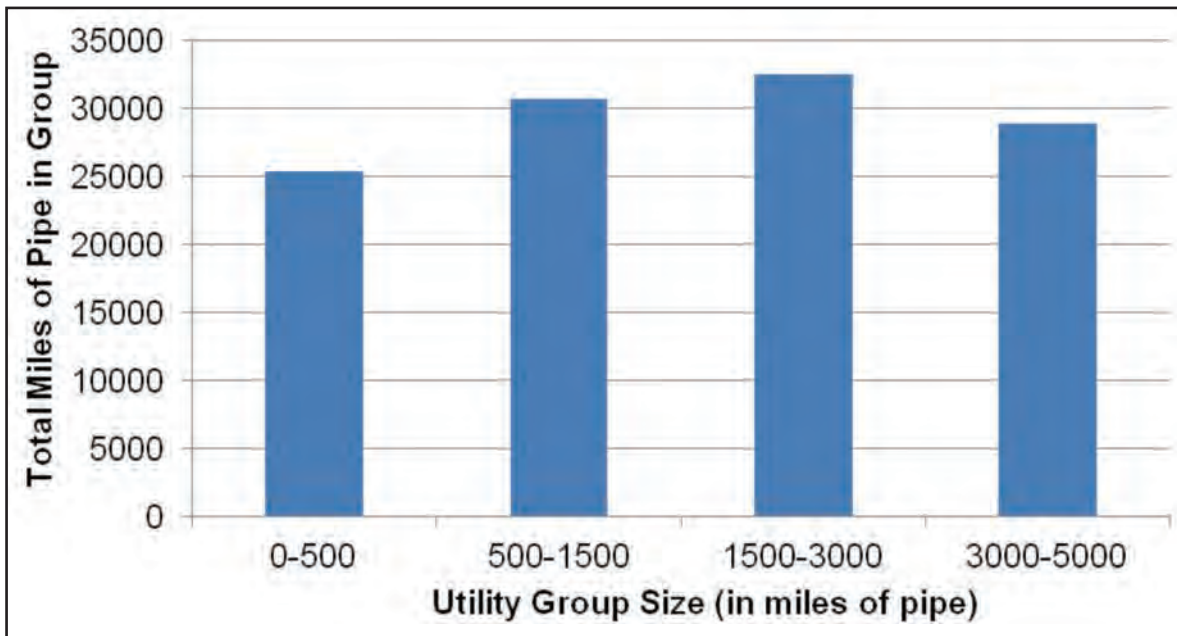
Figure 4. Total miles of pipe in each size group defined in Table 2 based on the basic survey respondents.

Four categories were established as shown in Table 2 and each survey participant was allocated to one of the categories. Figure 4 shows the distribution of total miles from the basic survey based on these categories. Respondents covered the range from very small to very large with each group from Table 2 well represented.

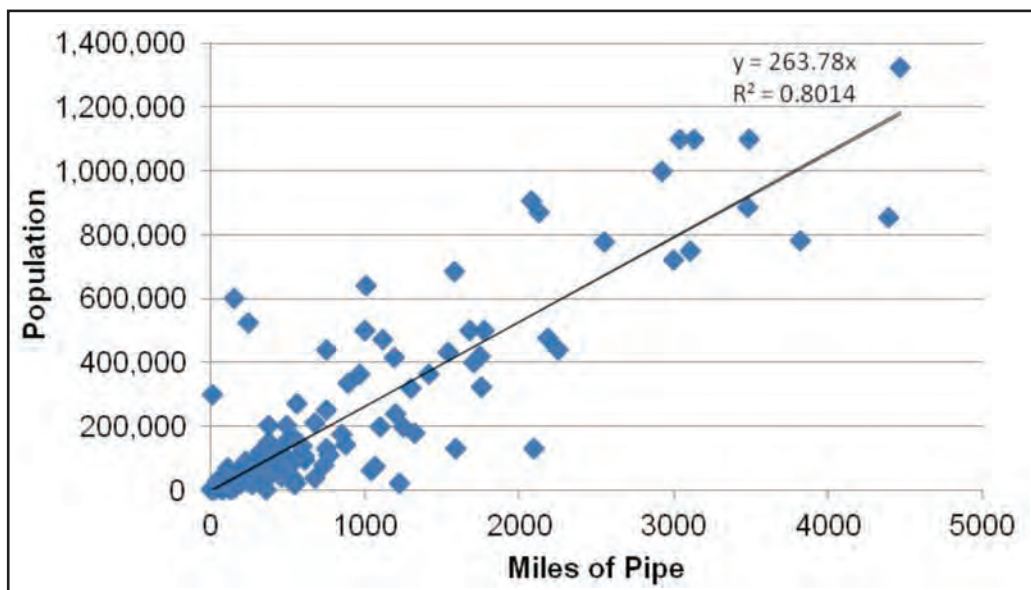
Figure 5. Population served relative to total pipe line miles from the basic survey.

Figure 5 illustrates the relationship between the population served by the utilities participating in the basic survey and the number of miles of water main pipe. The trend line and equation are a best fit to the data. The slope of this line indicates that there are on average 264 people served for each mile of water main installed.

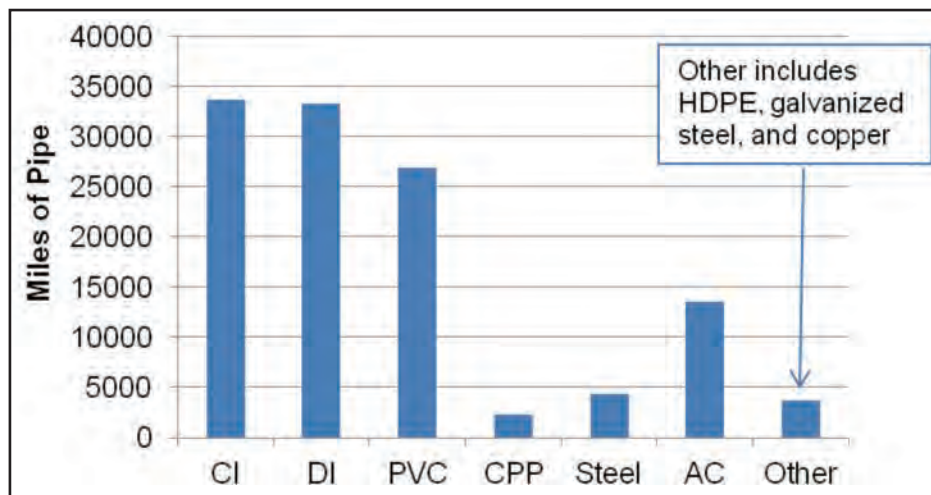
**Figure 6. Length of pipe broken down by material type from the basic survey.**

Figure 6 illustrates the length of pipe reported in the basic survey broken down by pipe material. The “Other” category in Figure 6 includes materials such as HDPE, galvanized steel, and copper. Figure 7 illustrates the length of pipe reported in the detailed survey broken down by pipe material. Figure 8 illustrates the pipe material distribution as a percentage of the total length from both the basic and detailed surveys. The distribution of miles of pipe is quite similar in Figure 8 indicating that the detailed survey with a smaller number of respondents still gives similar results.

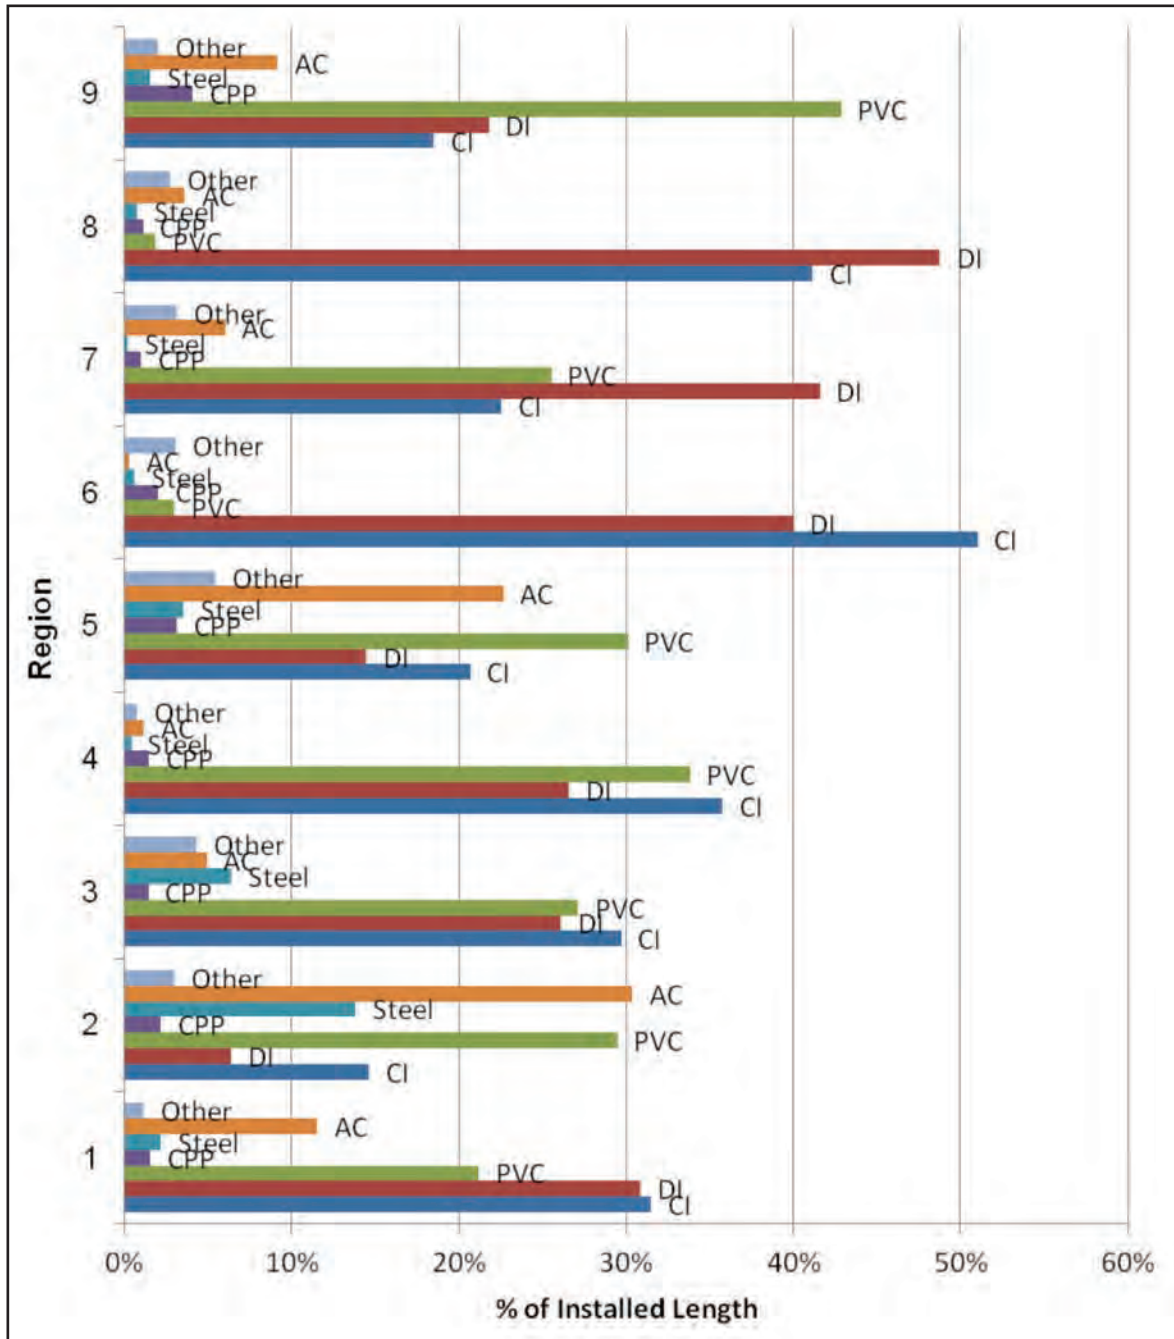
**Figure 9. Regional percentage of length of pipe by material type from the basic survey.**

Figure 9 illustrates the regional distribution of pipe material usage as a percentage of the total length in that region. It is interesting to note the significant differences in regional pipe material utilization. Cast and Ductile Iron represent approximately 90% of the pipe in regions 6 and 8. PVC has a dominant role in region 9 and is well established in regions 2, 3, 4, 5, and 7.

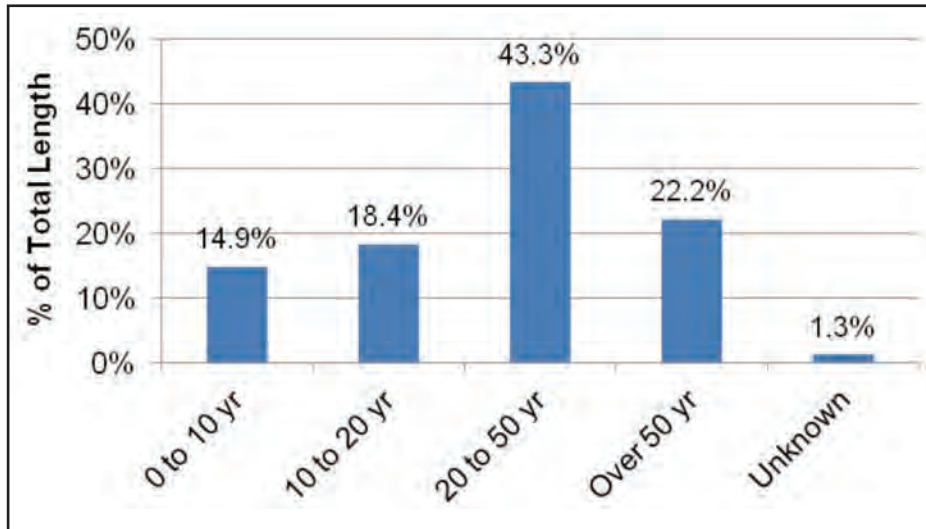
**Figure 10. Percent of length of pipe by age from the detailed survey.**

The detailed survey asked respondents to provide the distribution of installed pipe by age. Four age groups were provided; zero to 10 years, 10 to 20 years, 20 to 50 years, and over 50 years. Figure 10 lists the percentage of water main length that fits in each age category. Figure 10 indicates that approximately 43% of installed pipe are in the 20 to 50 year age category and 22% are over 50 years of age. This finding is consistent with other industry sources.

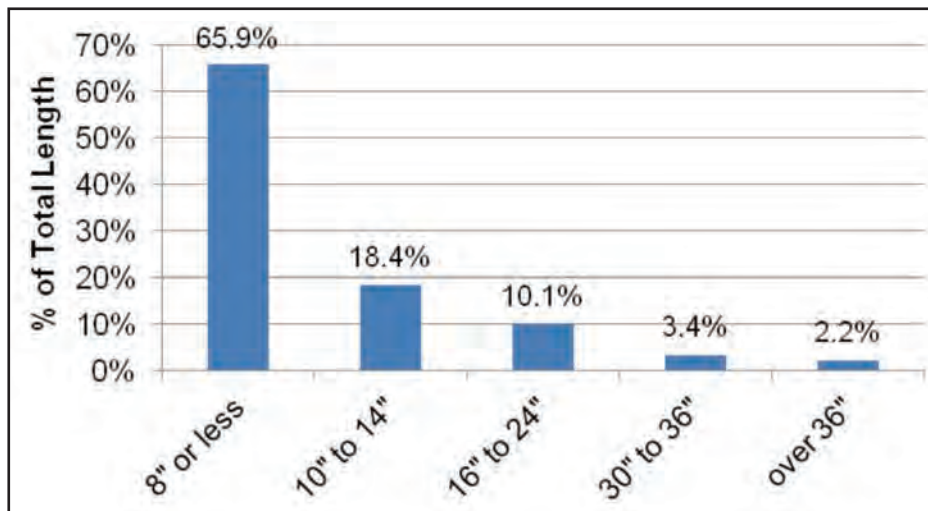
**Figure 11. Percent of length of pipe by pipe diameter from the detailed survey.**

The respondents were also asked to break down the fraction of total installed pipe length by five pipe diameter categories. Figure 11 illustrates the percentage of water main that fit into each size range. Figure 11 indicates that approximately 66% of the installed pipe is 8 inches or less in diameter.

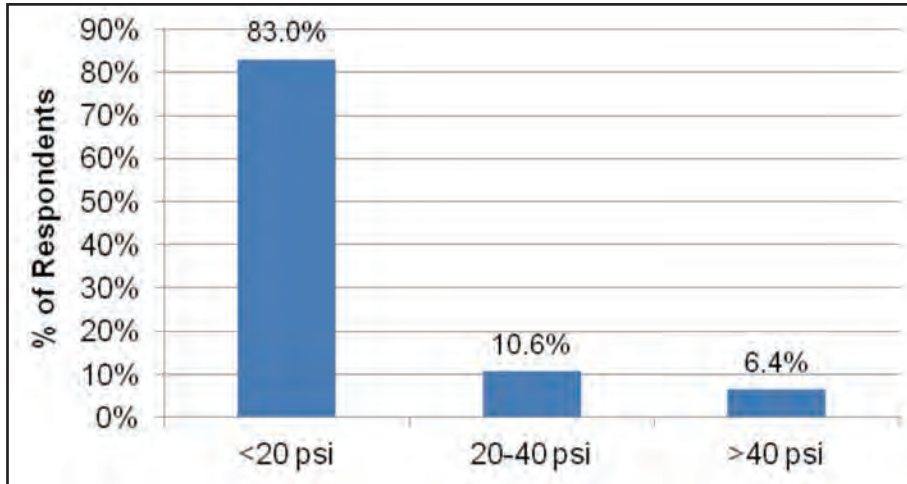
Figure 12. Percentage of respondents with one of three pressure fluctuation ranges.

Based on the detailed survey, the average delivery pressure is 77 psi. The range of values reported for average delivery pressure was 45 to 150 psi. The detailed survey also asked how much does the water pressure fluctuate at any given point in their system during a typical day. The respondents were asked to select one of three ranges. Figure 12 illustrates the percentage of respondents that fit into each pressure range. About 83% are able to limit pressure fluctuations to be less than 20 psi.

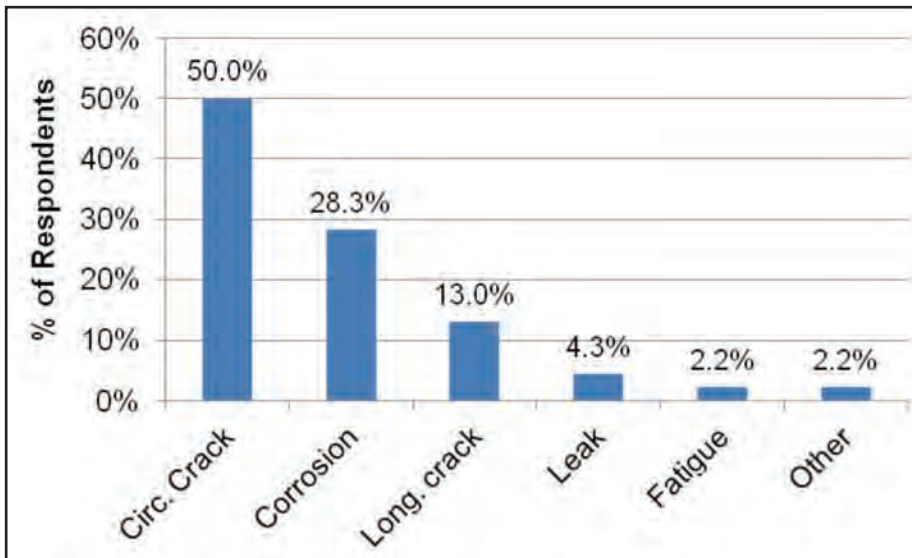
Figure 13. Percent of respondents selecting a most common failure.

The detailed survey asked the respondents to identify the most common failure mode by selecting from one of the following; corrosion, circumferential crack, longitudinal crack, leakage at joints, fatigue, or other. Figure 13 identifies a circumferential crack as the most common failure mode followed by corrosion. The detailed survey also asked respondents to identify the pipe material that was failing most often. Figure 14 shows that 55.3% of respondents identified Cast Iron as the most common failing pipe material followed by Asbestos Cement at 17.0%. The respondents also reported the typical age of a failing water main. The average result was 47 years with a range of values from 20 to 86 years. The survey also asked what the expected life should be when installing new pipe. The average expected life of new pipe was 79 years with a range of responses from 30 to 200 years.

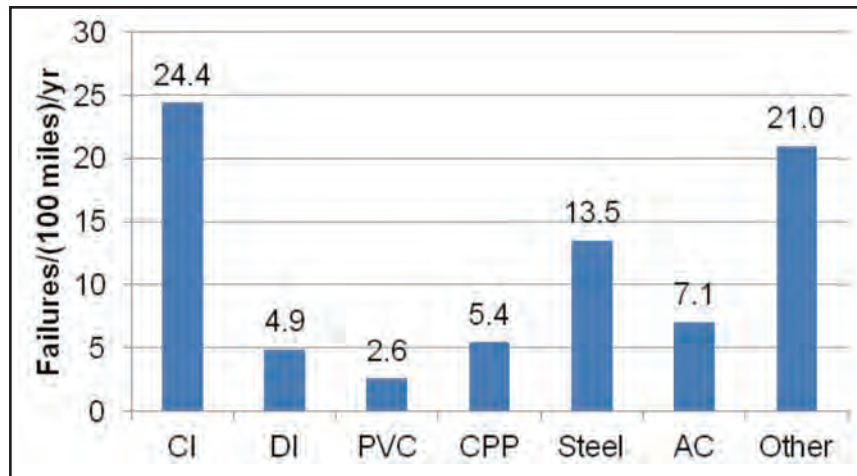
Figure 15. Failure rates of each pipe material from the basic survey.

The survey measured pipe failures over a recent 12 month period, broken down by material type. Table 4 lists the total length of pipe by material type, the number of failures over a recent 12 month period, and the failure rate for each pipe material. Figure 15 illustrates the failure rates as a function of material type. If one assumes a utility had equal lengths of each material installed, then Figure 16 would illustrate the percentage of failures as a function of pipe material. Figure 17 gives the failure rates broken down by material type and by respondents from the USA and Canada.

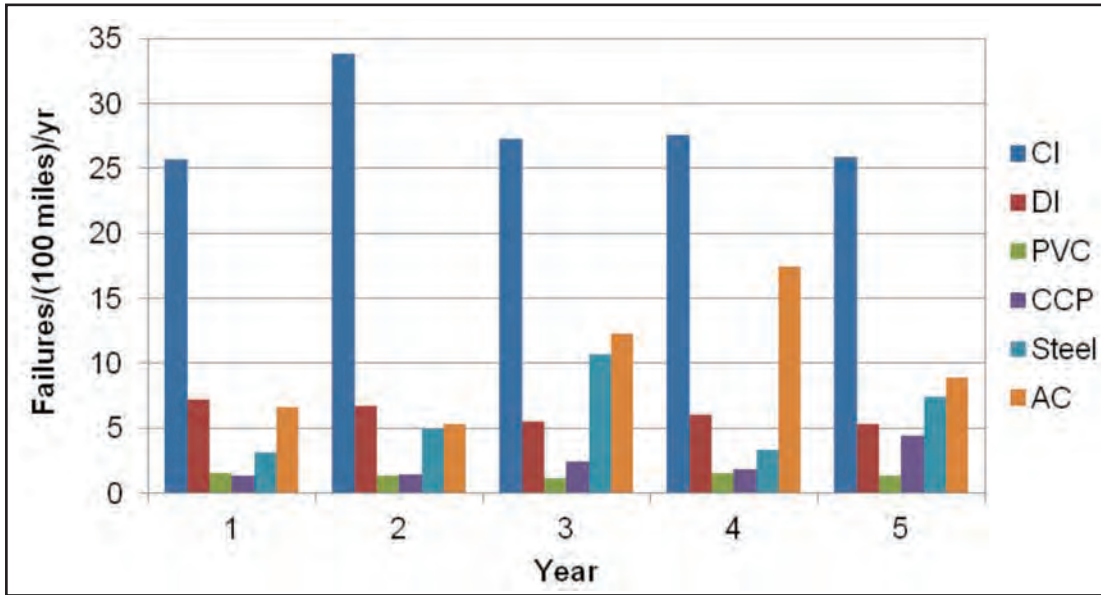
**Figure 18. Pipe failure rates over a five year period as a function of pipe material.**

The detailed survey requested the respondents to list the number of failures per year for five years, broken down by material type. The desired focus was to examine the year to year variations by pipe material. A single utility might have large year to year variations, but if the number of utilities sampled is sufficient, the year to year variation should be small. Figure 18 shows the failure rates from the detailed survey from each of the five years covered by the survey. Respondents that did not have five years of data were not included in these results.

Table 5 lists the average of the failure rates over the five year period along with the standard deviation and the coefficients of variation (the standard deviation divided by the average). The coefficients of variations for CI, DI, and PVC are similar indicating they have approximately the same variability. The widest variation in rates was associated with CPP, steel and AC pipe. The length of pipe in the detailed survey for these materials was small and more respondents could likely reduce the variability.

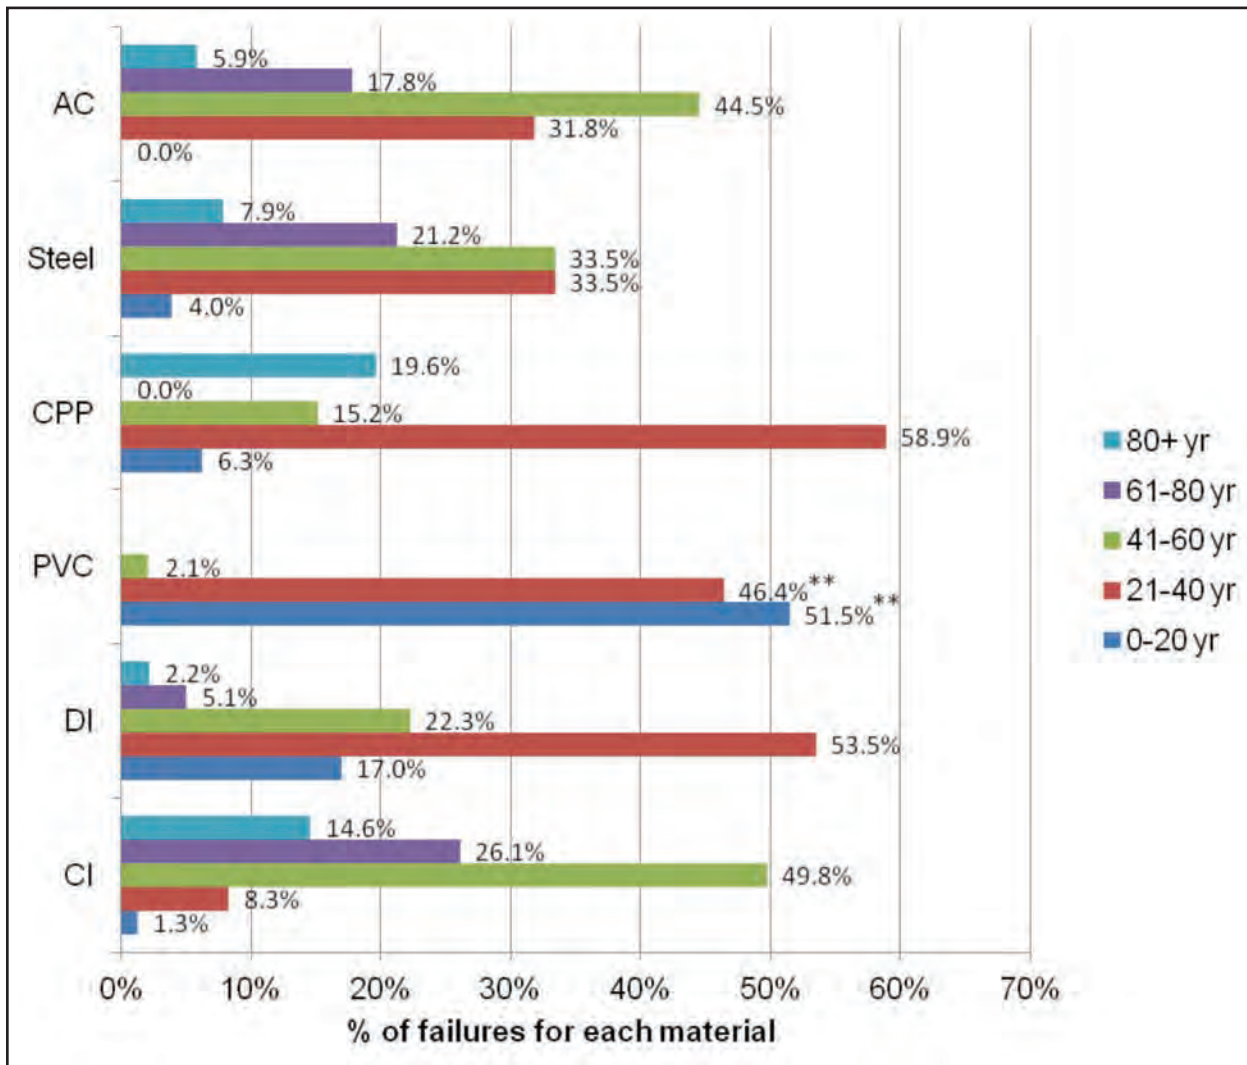
Figure 19. Percent of failures as a function of age and pipe material.

Clearly, pipe age will affect failure rates. The basic survey asked respondents to break down the failures into five different pipe age categories. It is noted that some of the respondents did not know the age of the failed pipes, and they were not included in the results below. For each material type, the fraction of failures in each age group is examined in Figure 19 based on the basic survey results. For example, 49.8% of the reported cast iron failures occurred with a pipe age between 41 and 60 years. Note that the largest percentage of failures is not in the oldest pipes, which has several possible causes. First, the older pipe is being replaced, and, thus, there is less available to fail.

The results in Figure 19 are related to when a pipe material was introduced or removed from the market. Asbestos Cement pipe has not been installed in the USA and Canada in the past 20 years, and, thus, all AC pipe failures exceed 20 years of age. Widespread DI and PVC pipe production in the USA did not start until about 1970, so we should expect to see a small failure percentage for both DI and PVC in the 41 to 60 year age group and none for the 61 to 80 and 80+ age groups. PVC follows that trend in Figure 19. Figure 19 shows the majority of DI pipe failures occur at an age between 21 and 40 years. The DI results in Figure 19 for the 61 to 80 and the 80+ age groups are possibly caused by incorrect records on the age of those failed pipes.

It is of interest that Figure 19 shows a greater percentage of PVC pipes fail in the first 20 years of use than in the next 20 years\*\*. This was investigated in a previous survey funded by AWWARF (Moser, 1994). Figure 20 illustrates the percent of failures as a function of time for AWWA rated PVC pipe. As shown below, over 40% of the reported failures occurred in the first year. Often the cause of these failures in PVC pipe is related to improper installation practices and not a defect in the pipe. The city of Calgary has been able to achieve remarkably small PVC failure rates due to enforced construction standards (Brander, 2004). In addition, Calgary requires new subdivision infrastructure to remain the property of the private developer for a period of two years. During this two year period, most construction related problems will occur. An AWWARF study (Burn, 2006) estimates the design life of PVC to be in excess of 110 years.

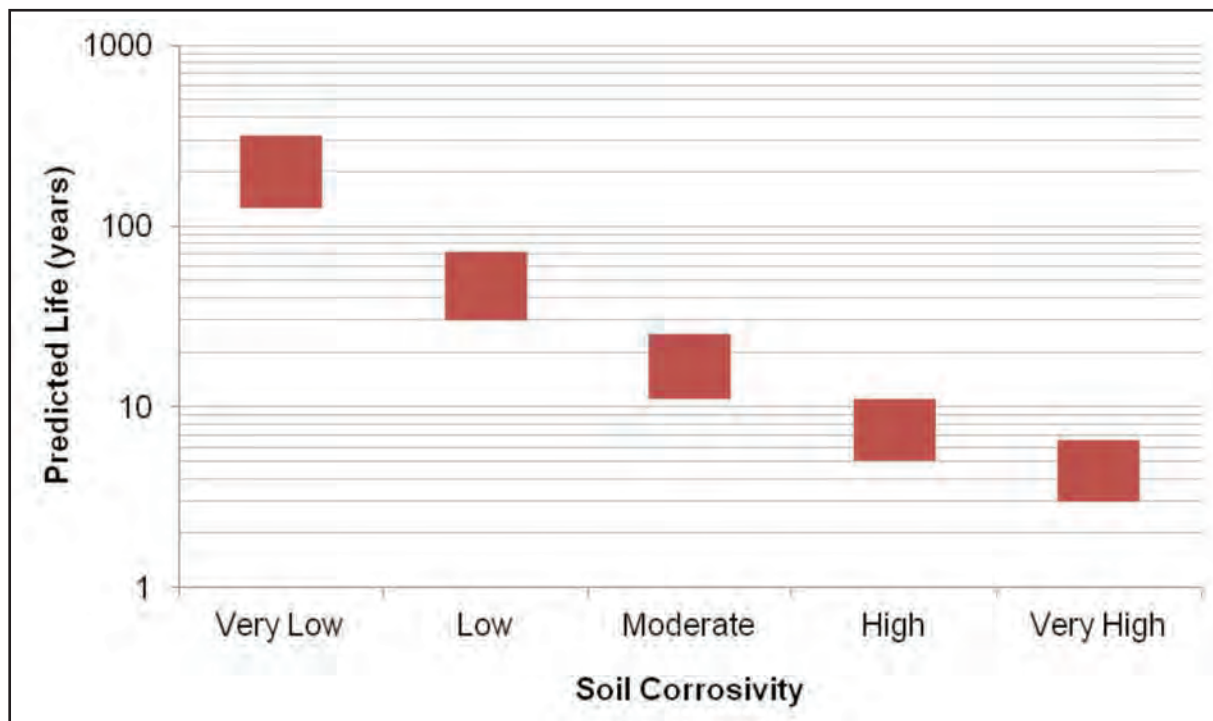
Figure 21. Predicted life of unprotected class 350 DI pipe (from Rajani, 2011).

The expected life in years of an unprotected DI pipe was estimated in a recent Water Research Foundation study (Rajani, 2011). Figure 21 illustrates the published results as a function of a relative scale of soil corrosivity. Figure 19 indicates that the majority of DI pipe failures occur at an age between 21 and 40 years. A 21 to 40 year life in Figure 21 would correspond to a low to moderate soil corrosivity for an unprotected pipe. This would indicate that corrosion is a significant problem in all regions of this study. When a comparison is made between Cast Iron and Ductile Iron, thinner-walled Ductile Iron is experiencing failures more rapidly (21-40 year period) than the thicker-walled cast iron (41-60 year period). Concrete Pressure Pipe also shows failures rates that are impacted by corrosion in the 21-40 year period. The study also notes that “aging or deterioration of ductile iron pipes can vary significantly from one geographical region to another within a city, let alone from city to city.”

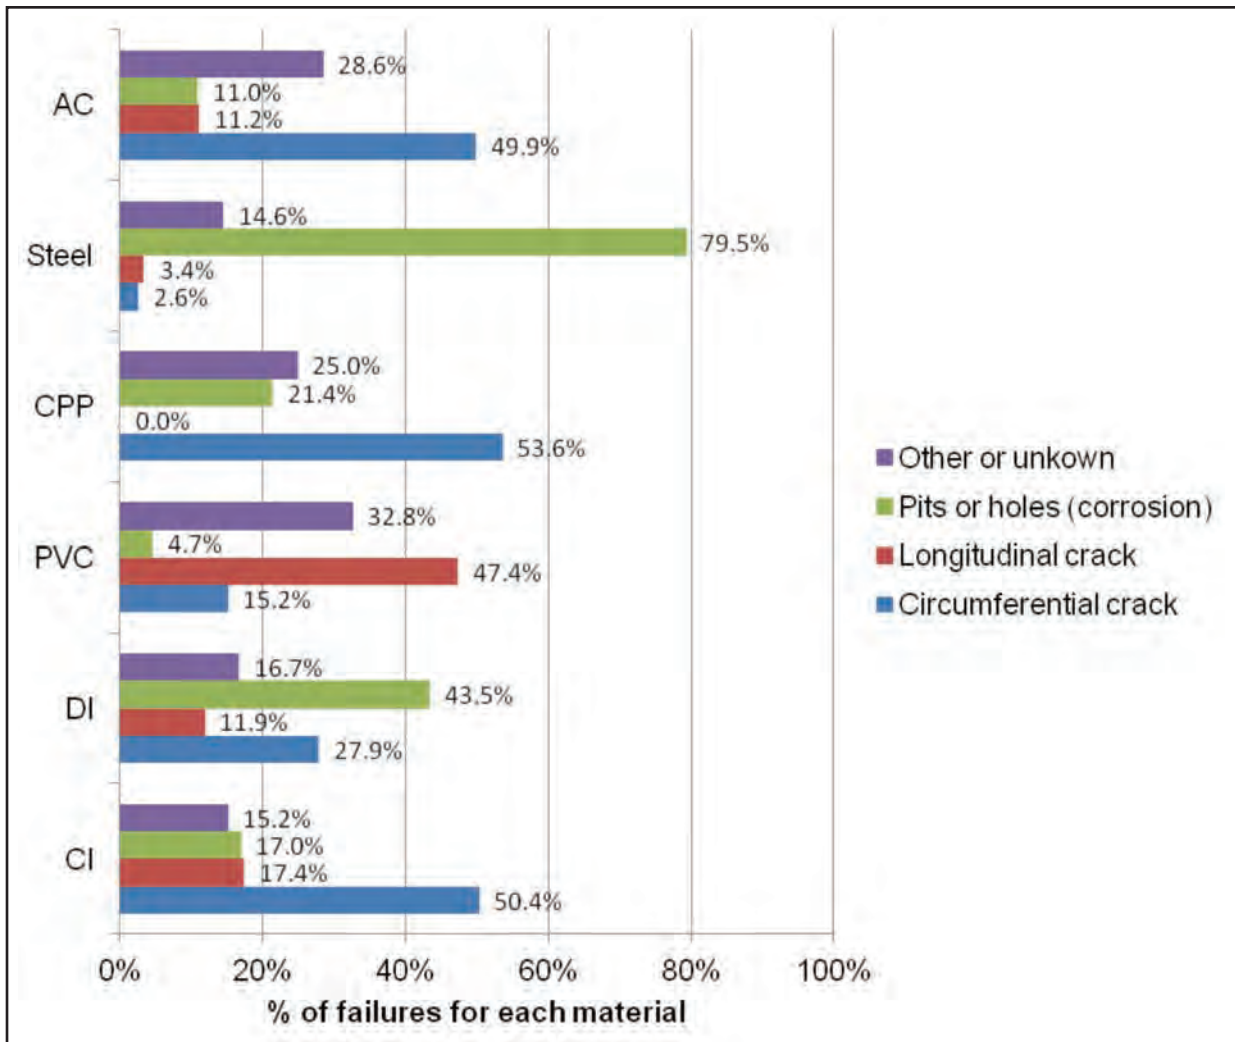
**Figure 22. Description of failure for each pipe material.**

Figure 22 summarizes the percentage of failures that were reported to fit in each description. A circumferential crack is the primary failure mode for Cast Iron, Concrete and Asbestos Cement pipe. Corrosion is the primary failure mode of Ductile Iron and Steel pipe. A longitudinal crack is the primary failure mode of PVC.

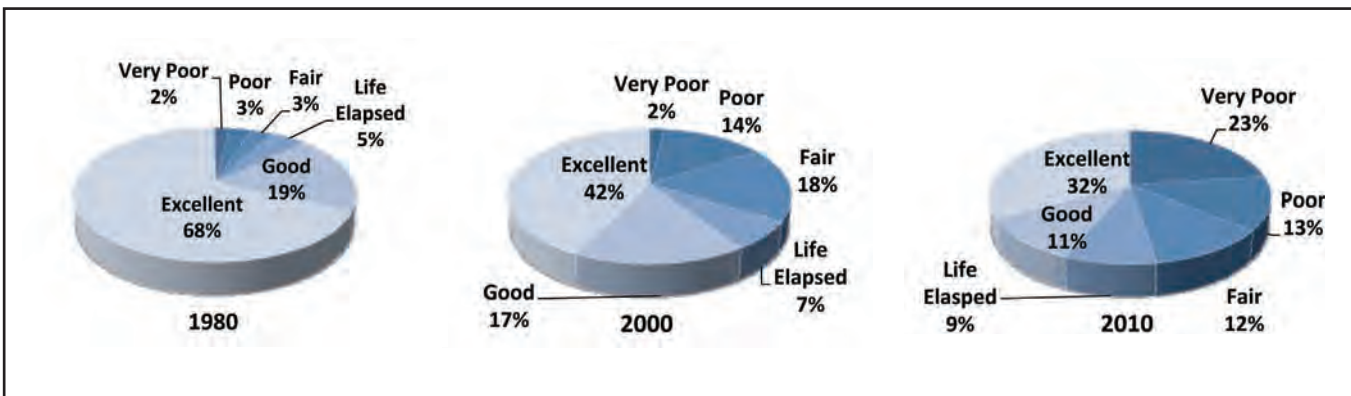
**Figure 23. Assessment of pipe condition with time (from EPA, 2002).**

It is of interest to compare these results with a study done by the EPA (EPA, 2002). This study classified water main pipe condition into six categories; Excellent, Good, Fair, Poor, Very Poor, and Life Elapsed. The study examined data for years 1980 and 2000 and forecasted data for 2020. Figure 23 below is reproduced from their report and shows that the above mentioned survey average response of 8.4% of pipe are beyond their useful life would correspond well with the “Life Elapsed” category in Figure 23. It is very important to note the projected growth in the “Very Poor” condition category in Figure 23. The rate of growth in that category will make it much more difficult for utilities to get that pipe replaced before it reaches the “Life Elapsed” category. An AWWA study (AWWA, 2012) echoes this trend as illustrated in Table 6. Table 6 shows aggregate costs to cover both replacement and growth in water mains in the USA.

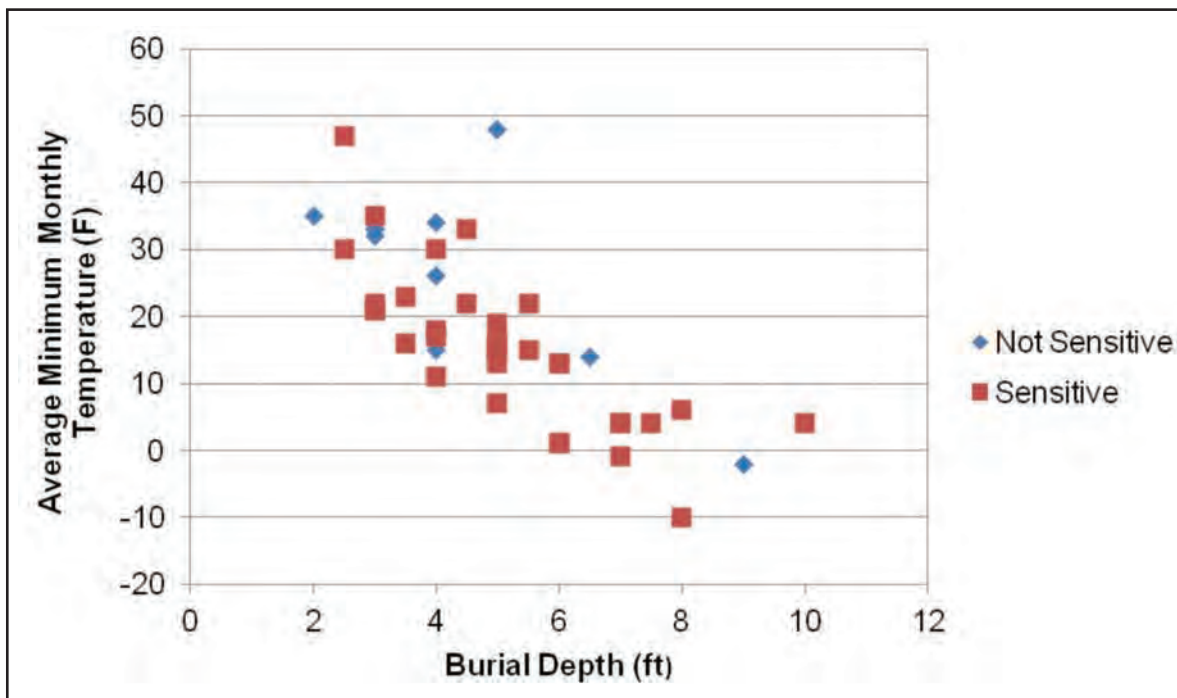
**Figure 25. Correlation of the lowest average minimum monthly temperature during the year and burial depth. Red symbols note locations where failures increase with low ambient temperatures.**

The detailed survey asked if the utility observed an increase in water main failures with extreme ambient temperatures, either warm or cold. The results of the survey indicated that 72% of the respondents did note an increase in pipe failures with extreme cold ambient temperatures and only 13% reported a correlation with warm temperatures. Clearly this result would be dependent on the climate at each utility. The average depth of burial was also reported. An effort was made to see if there is a correlation between temperatures extremes and burial depths. For each utility the temperature extremes were derived from average monthly temperatures. The highest average monthly temperature in the summer and the lowest average monthly temperature during the winter were recorded for each utility location.

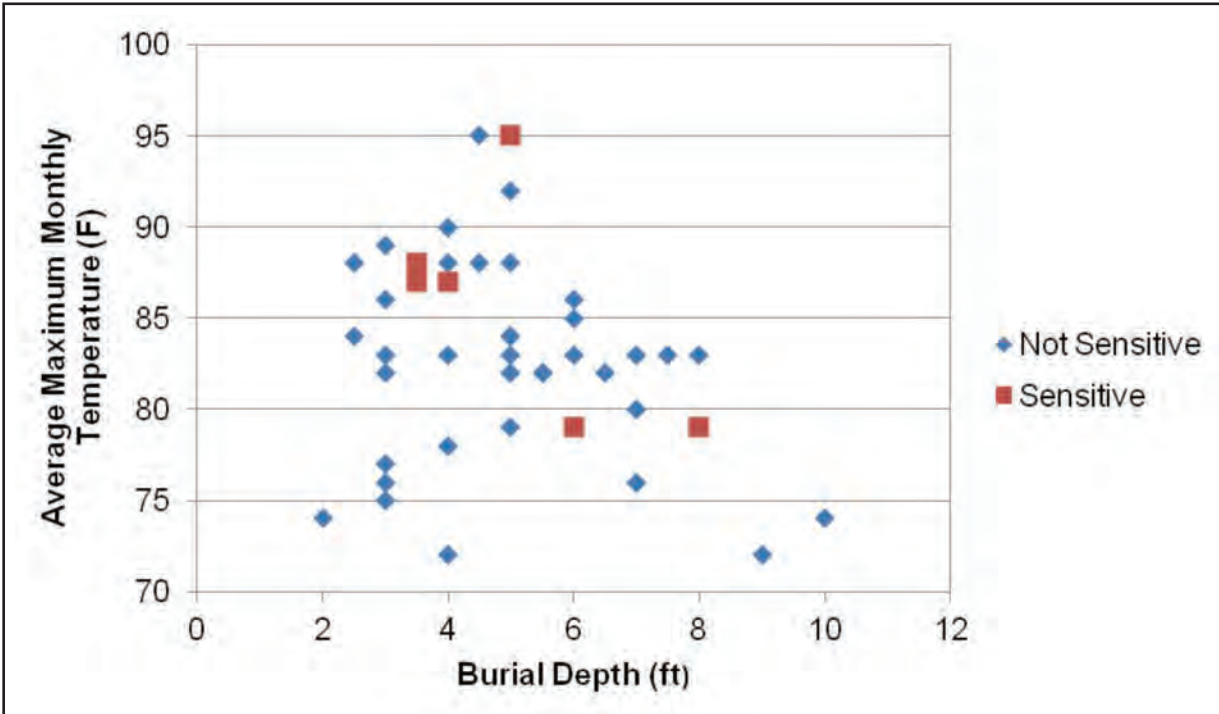
**Figure 26. Correlation of the highest average maximum monthly temperature during the year and burial depth. Red symbols note locations where failures increase with high ambient temperatures.**

Figure 26 plots the highest average maximum monthly temperature during the year for each respondent versus their reported average burial depth. Again, the color of the symbol indicates whether that utility reported to be sensitive to high ambient temperatures. Again, no correlation was observed.
